Land use changes and water quality of Sal River in Goa

Bindu Sulochanan, Lavanya, S., Sampath Kumar, G., Prathibha Rohit and Kripa, V.
Mangalore Research Centre of CMFRI, Mangalore

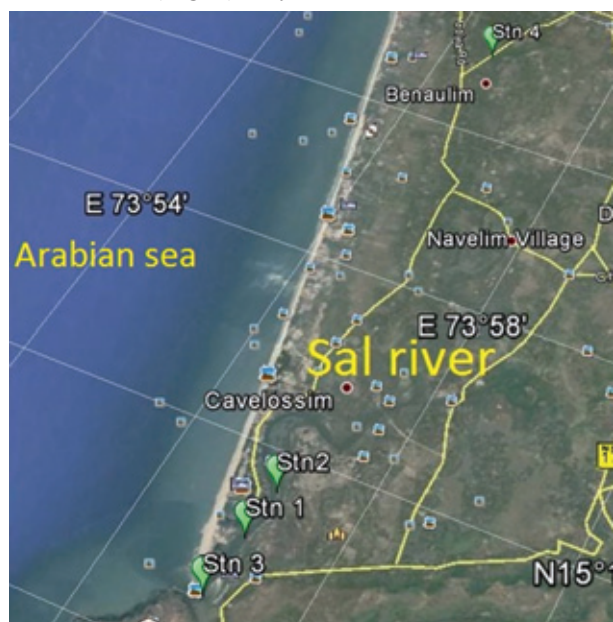
Fig. 1 Sampling locations along river Sal

Based on recent reports of mortality of short-neck clam *Paphia malabarica*, *in-situ* observation was conducted on 1.5.2014 from four sites along river Sal. The local fishermen stated that the mortality commenced from March 2014. The site where clam mortality was reported is adjacent to Cavelossim and Mabor. Station 1 and 2 are clam bed sites, station 3 is the river mouth opening to the sea, Station 4 is the site where sewage effluent enters Sal (Fig.1). Oyster beds were observed

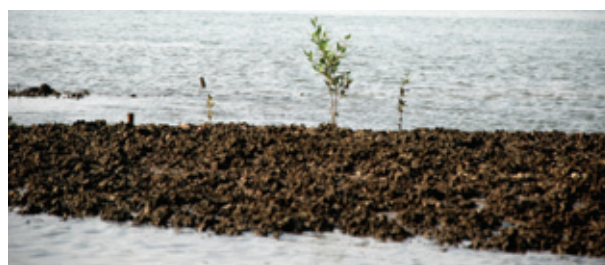
Fig. 2. Oyster shells on river bank

adjacent to Station 2 which is a clam bed area. Shucked oyster shells were also observed on the river bank, on the upfront of which the hotels and restaurants were located. On the banks as well as upstream of the river, litter was observed (Fig. 2).

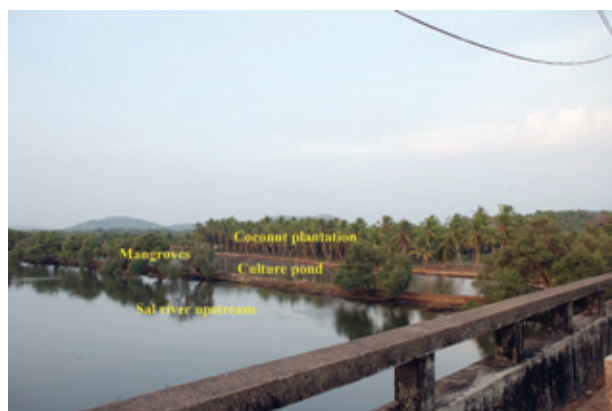
Fig. 4 Culture pond between mangroves and coconut plantation

The water quality at station 4 which is very near to the sewage treatment plant was observed to be good. Mangroves of fringing type were observed on the banks of river. Its roots prevent litter from reaching the river and also in the stabilization of sediment. This helps in maintaining the water quality of the river. Destruction of mangrove area for culture ponds and coconut cultivation was also noticed downstream of Station 4.
