MARINE FISHERIES INFORMATION SERVICE

No. 75
SEPTEMBER 1987

BEACH EROSION AT KOVALAM FISHING VILLAGE, TAMIL NADU, WITH SOME COMMENTS ON THE SEASONAL SHIFTS IN THE COASTLINE ALONG THE KOVALAM BAY*

*Prepared by Geeta Bharathan and E. V. Radhakrishnan, Madras Research Centre of CMFRI, Madras.

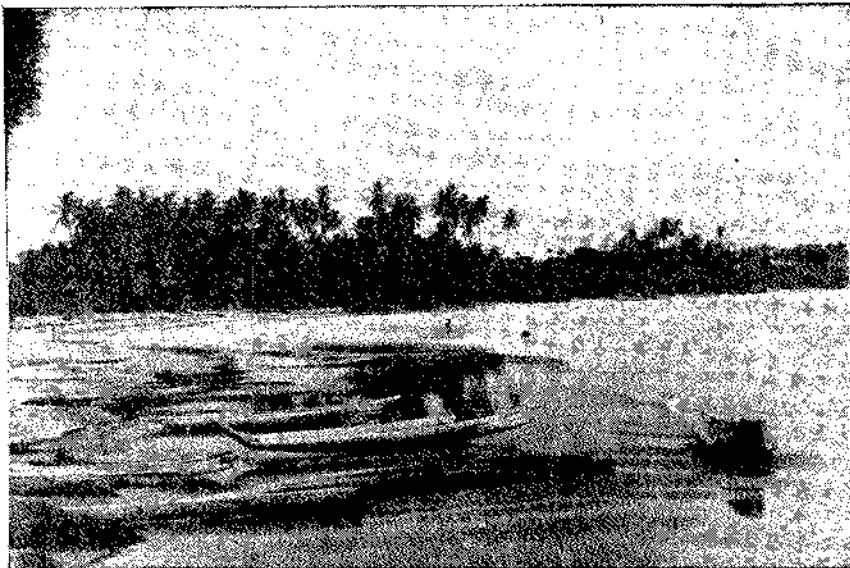
Fig. 2. The Kovalam beach in July, 1985. Note the flat profile of the beach compared to the sand mound in Fig. 10.

settlement, consisting of thatched, as well as 'pukka' houses, is located very close to the sea on a sand mound of 2 m high. These houses were hidden behind a thick grove of coconut palms (Fig. 2) until calamity in the form of severe sea erosion struck the village during May-June, 1986. Over 150 coconut palms and 13 houses were destroyed (Fig. 3 & 4) and several others damaged severely, affecting the livelihood of many households. Temporary relief came in the form of piles of sand bags (Fig. 5) to prevent further damage. The sea receded by the last week of June and there was no further threat to the village.

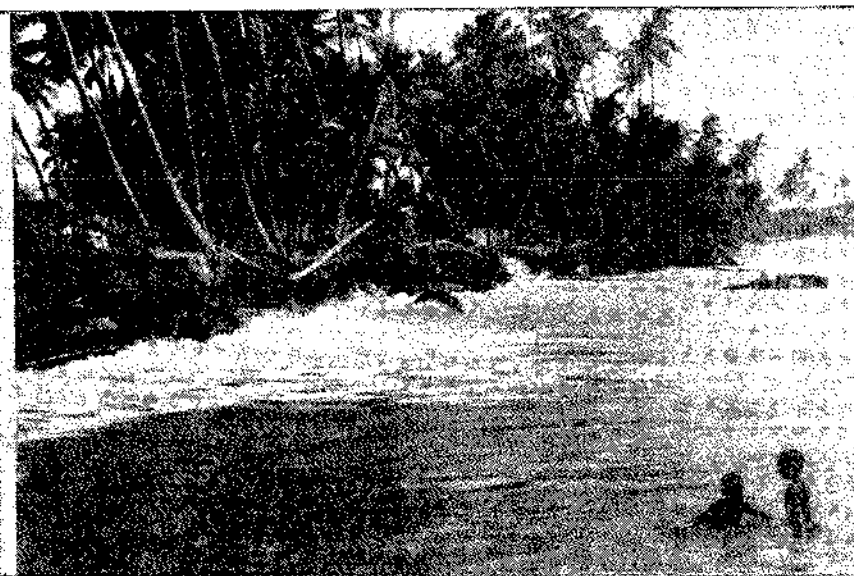
Fig. 3. View of erosion of palm grove as on 30th May, 1986.

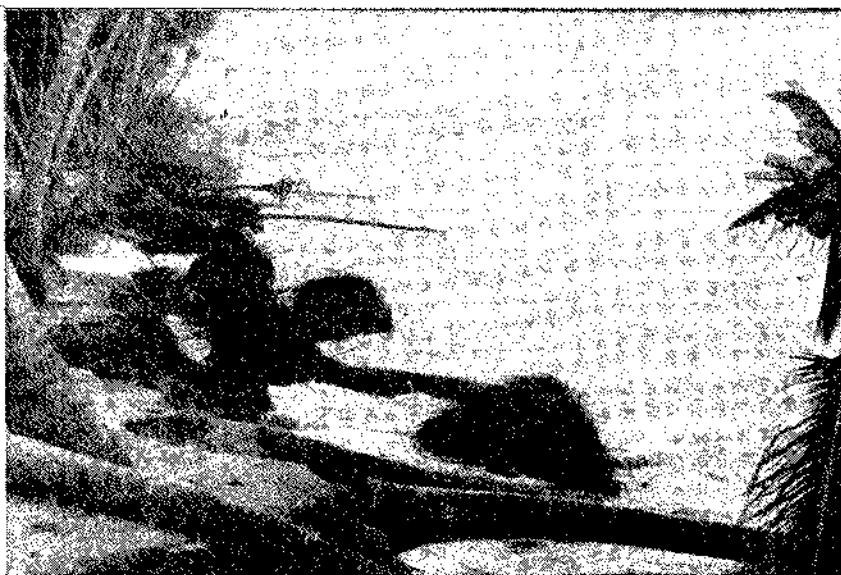
Fig. 4. Close-up view of erosion, 30th May, 1986.

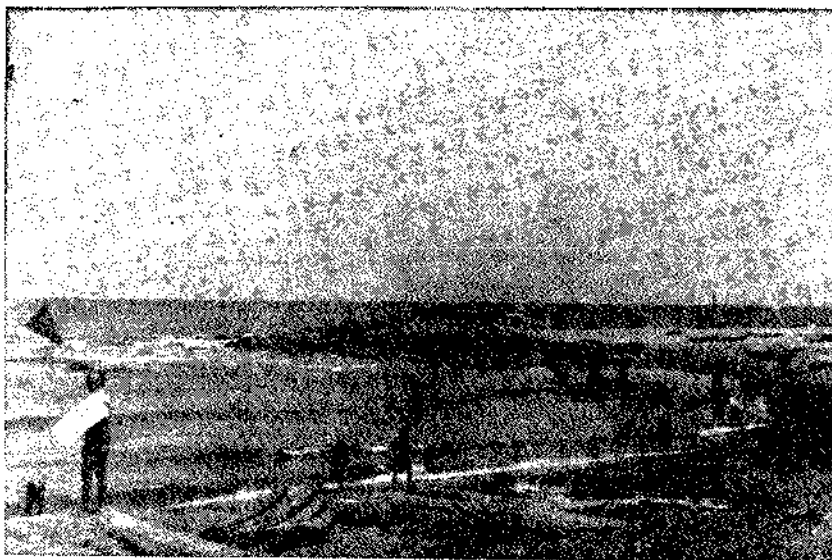
Fig. 8. Incursion of sea. Arrow indicates new crop of rocks exposed.

In 1986 the sea did not retreat in April as it normally does, but remained close-by until May, exposing a new crop of rocks on the shore and eroding away different parts of the beach (Fig. 8). Shore seines landed large quantities of anchovies (about 2 tonnes) during this period. The sea became very rough during the lunar eclipse on April 24, 1986 and erosion increased. A huge anchor, 2 m high and weighing nearly 2 tonnes was uncovered by the sea (Fig. 9). Subsequently, by the second week of May, the sea started receding and a small sand mound was built up parallel to the coast on the beach in front of the Field Laboratory (Fig. 10).

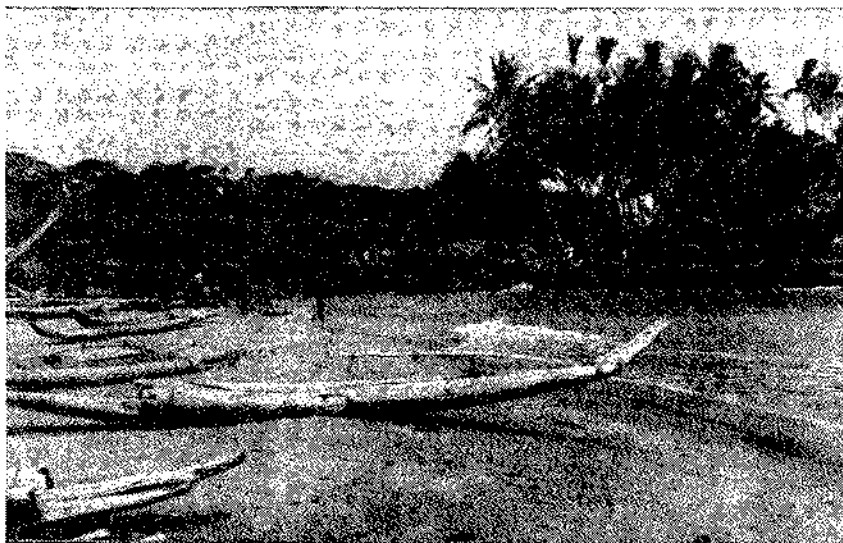
Fig. 10. View of beach showing sand mound formed after retreat of sea, 30th May, 1986.

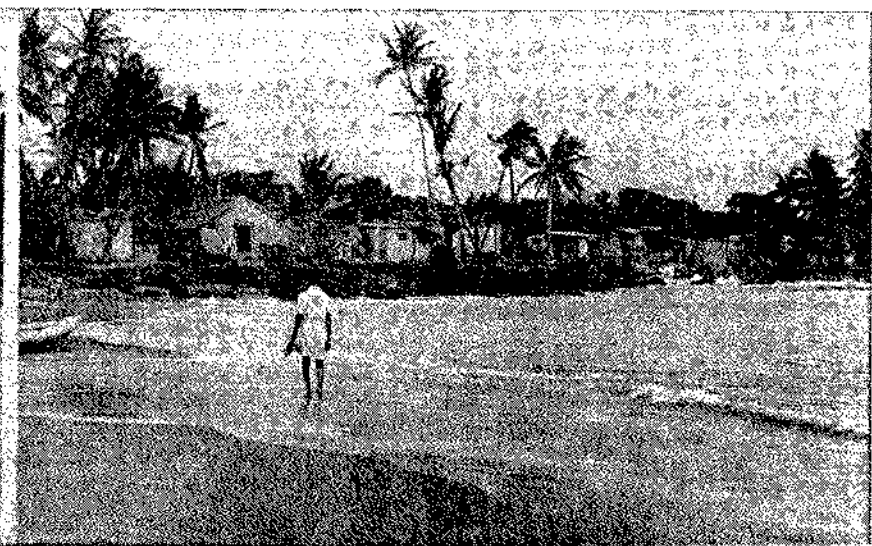
Fig. 11. Damages caused to the houses, 24th June, 1986

The sea again became rough on May 23, full moon night and then started the process of erosion of the village. Apparently, erosion was severe because of the newly formed sand mound which deflected the surging sea away from the direction of the road into the village (Fig. 11). A large palm grove at the southern end of the village was destroyed and by May 29, much of the sand in that area was eroded away and two ancient sculptures were uncovered (Fig. 12). Similar monoliths had been removed in 1968 too (Fig. 13). The sea then moved further north, and entered the village to a distance of nearly 60 m from the normal water line, destroying 10 huts and 3 'pukka' houses (Fig. 14). It became calm by June 28 when no more damage was caused and by July it had receded well back (Fig. 15).

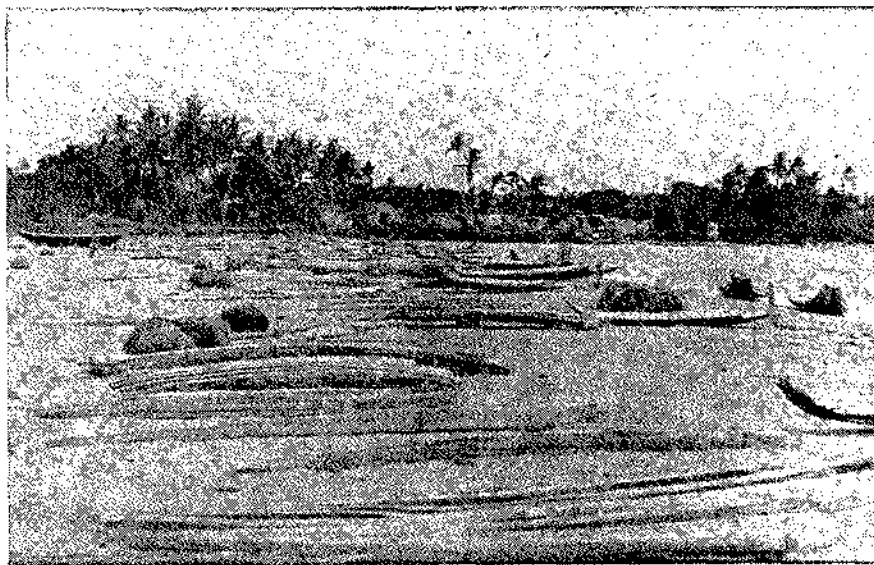
Fig. 14. A view of the village after destruction of houses and coconut palms taken place on 24th June, 1986. Compare the sparse stand of trees with the dense grove in Fig. 2.
