# **MARINE FISHERIES INFORMATION SERVICE**

No.26  
December 1980

## POSSIBILITY OF USING POLYTHENE LINED PONDS FOR MARICULTURE IN SANDY BEACHES\*

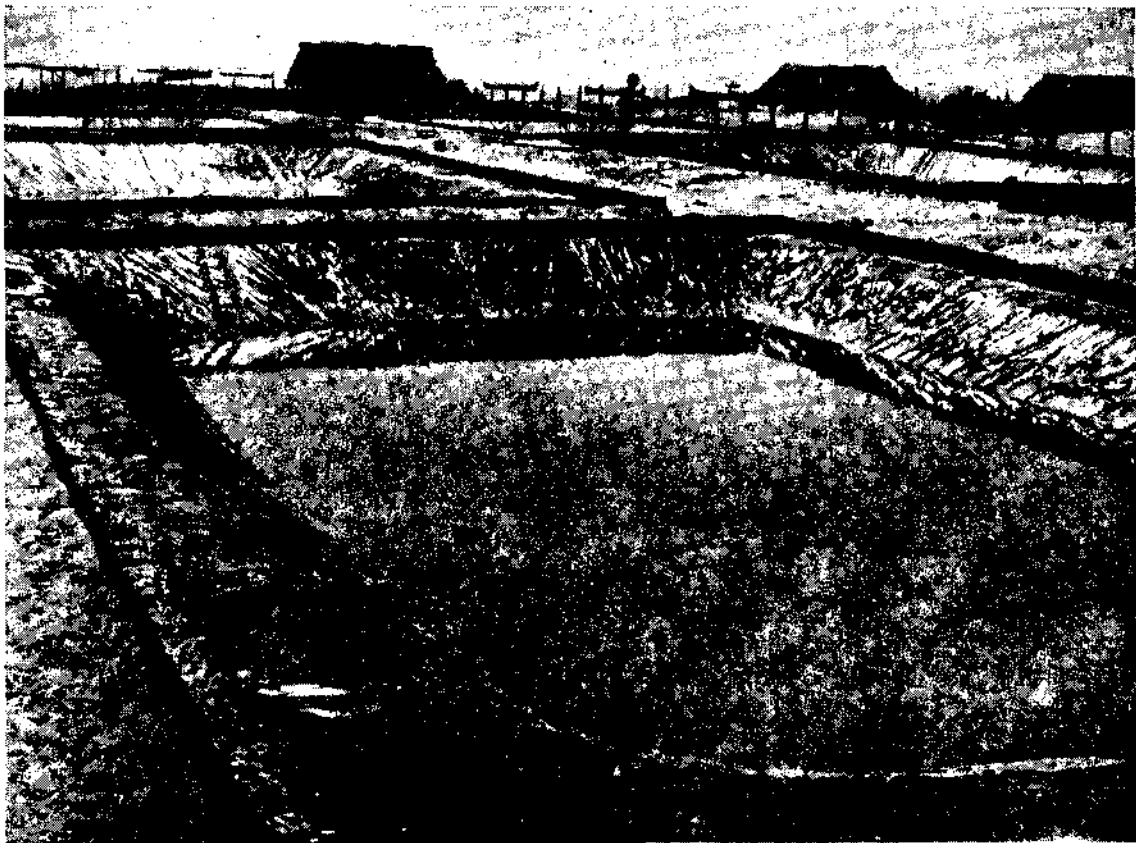
Fig. 1 A view of the polythene lined ponds.

The sandy sea shore of about 0.5 ha area in front of the Research Centre at Calicut was utilised for making the fish farm. The thorny bushes were removed and ponds of various areas—0.01 ha, 0.025 ha and 0.1 ha were excavated with a slope of 60° and a depth of 1.5 m. Care was taken that no sharp edged hard materials like glass pieces or stones are left on the sides and

bottom of the excavated pond. After levelling properly, the pond is provided with the polythene lining.

The lining of the ponds by the film is done by anchoring the free ends of the film around the pond by making a trench of 30 cm deep and 40 cm wide. The free ends of the film is anchored inside the trench and sand is placed over it. The lining should not be tight. After the completion of the lining the ponds can be bordered with laterite stones so as to prevent the sand being blown into the ponds (Figs 1 & 2). The bottom of the pond can be spread with sand of about 10 cm thickness so as to provide the culture animals with substrata. This will also help to prevent the heat being absorbed by the black polythene lining causing rise in the water temperature.

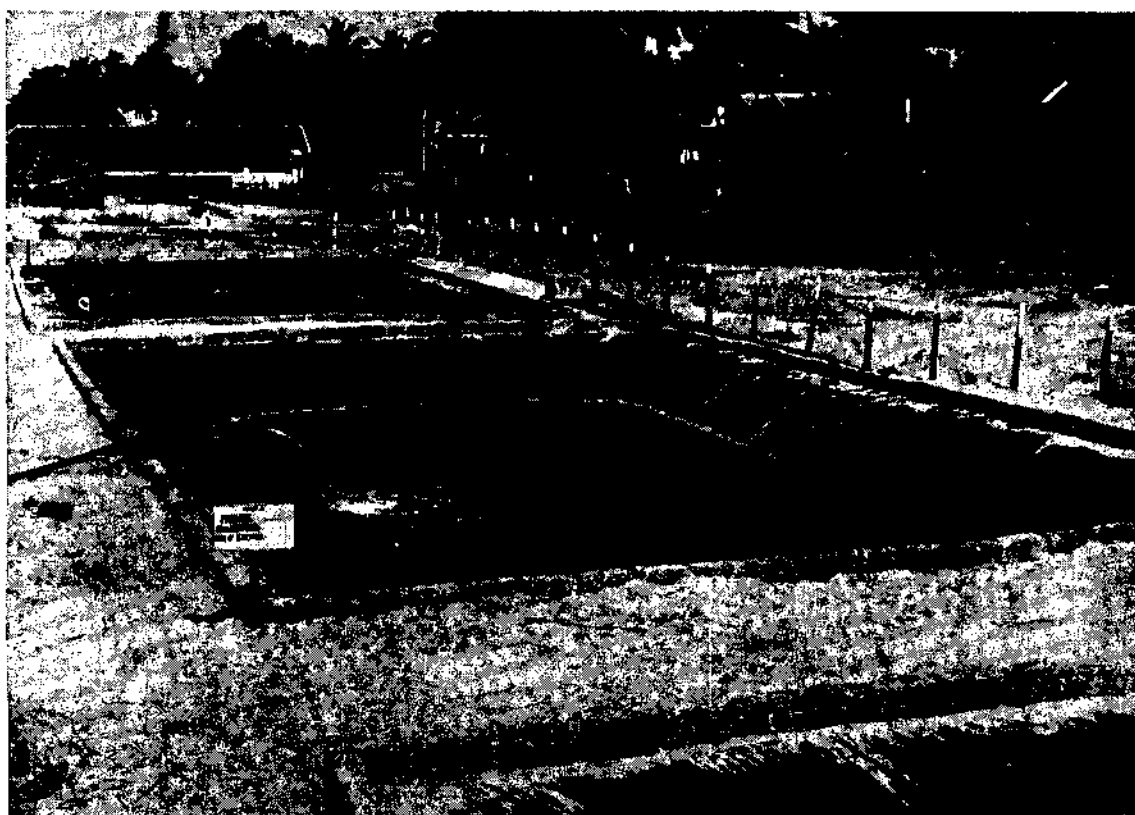
Fig. 2 A view of the polythene lined ponds.

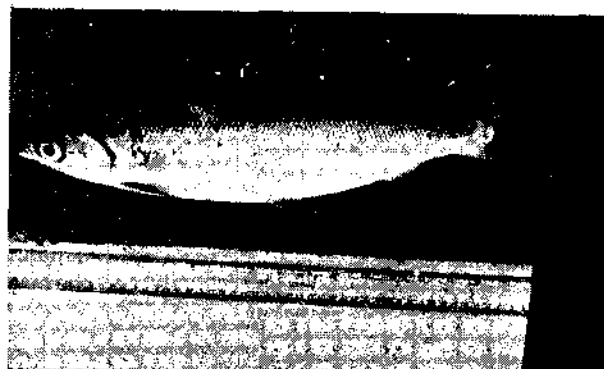
Fig. 4 *Chanos chanos* cultured in the fish pond.

stocking the fingerlings of the milk fish *Chanos chanos* in a pond of 0.01 ha it was possible to grow the fish to a size of 422 mm in 526 days (Fig. 4).
